DEPARTMENT OF TRANSPORTATION**DIVISION OF ENGINEERING SERVICES**

Quality Assurance and Source Inspection

Contract #: 04-0120F4Cty: SF/ALA Rte: 80 PM: 13.2/13.9File #: 1.28**WELDING INSPECTION REPORT****Resident Engineer:**Siegenthaler, Peter**Address:** 333 Burma Road**City:** Oakland, CA 94607**Report No:** WIR-024246**Date Inspected:** 02-Jun-2011**Project Name:** SAS Superstructure**OSM Arrival Time:** 700**Prime Contractor:** American Bridge/Fluor Enterprises, a JV**OSM Departure Time:** 1930**Contractor:** American Bridge/Fluor Enterprises, a JV**Location:** Job Site**CWI Name:** Steve Jensen and Pat Swain**CWI Present:** Yes No**Inspected CWI report:** Yes No N/A**Rod Oven in Use:** Yes No N/A**Electrode to specification:** Yes No N/A**Weld Procedures Followed:** Yes No N/A**Qualified Welders:** Yes No N/A**Verified Joint Fit-up:** Yes No N/A**Approved Drawings:** Yes No N/A**Approved WPS:** Yes No N/A**Delayed / Cancelled:** Yes No N/A**Bridge No:** 34-0006**Component:** SAS Tower**Summary of Items Observed:**

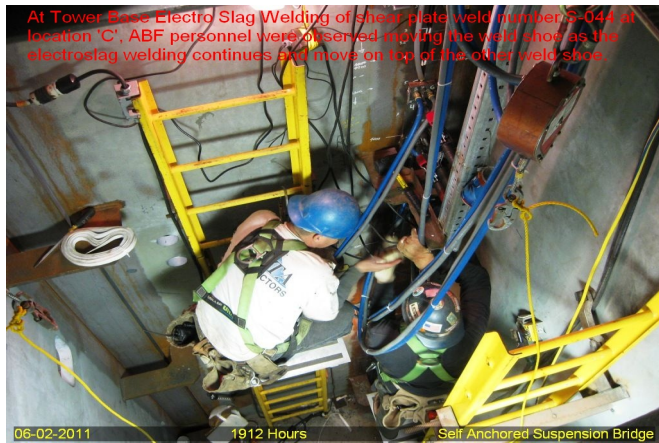
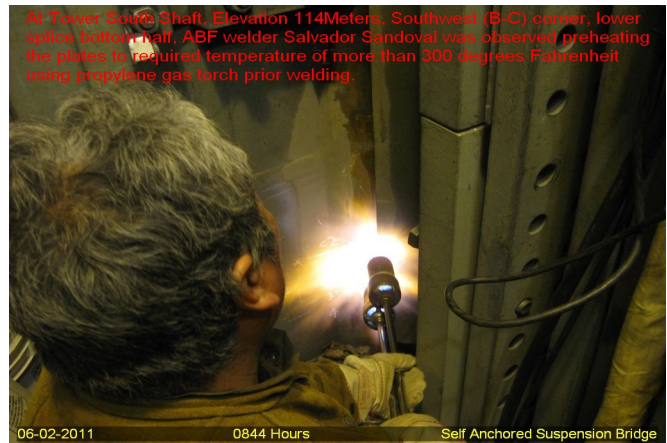
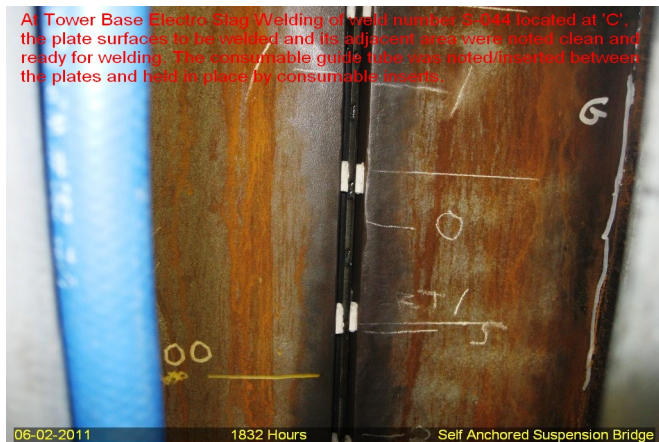
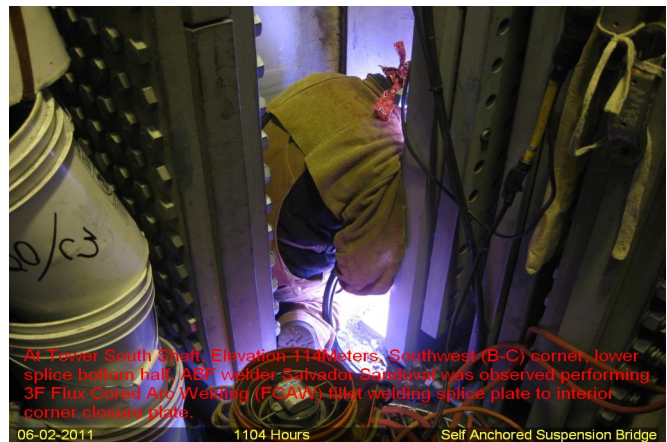
At approximately 1240 hours, this QA was present at the Tower Base to observe the Electro Slag Welding of the weld number S-044 located at 'C' position per ABF weld map. The weld joint to be welded is a 60-70mm transition butt joint located at the corner of tower skin plates 'A' and 'E' and to implement Caltrans approved welding procedure ABF-WPS-ESW-60-70TR.

Upon QA's arrival, ABF personnel were noted preparing to weld the shear plate butt joint by checking all the necessary electrical and water hose weld shoe cooling connections. They were all in place prior to commencing of the ESW. It was noted that three weld shoes were in position at each opposing side of the joint and so was the consumable guide tube that was placed in between the joint gap.

Initial welding of the ESW had started at 1518 hours. There were problems with the initial start of the welding due to bad electrical continuity according to ABF QCM Mr. Jim Bowers. ABF Superintendent Dan Ieraci and other personnel checked and re-checked again all connections until they finally were satisfied and re-started at around

1712 hours. This time the re-starting of the ESW was successful and the welding parameters have stabilized.

Welding continued until the completion of the joint.
